POPPLETON HISTORIC STUDY

B-2764

<u>Block</u>	<u>Lot</u>	<u>Address</u>
253	58-66	875-891 Lemmon Street

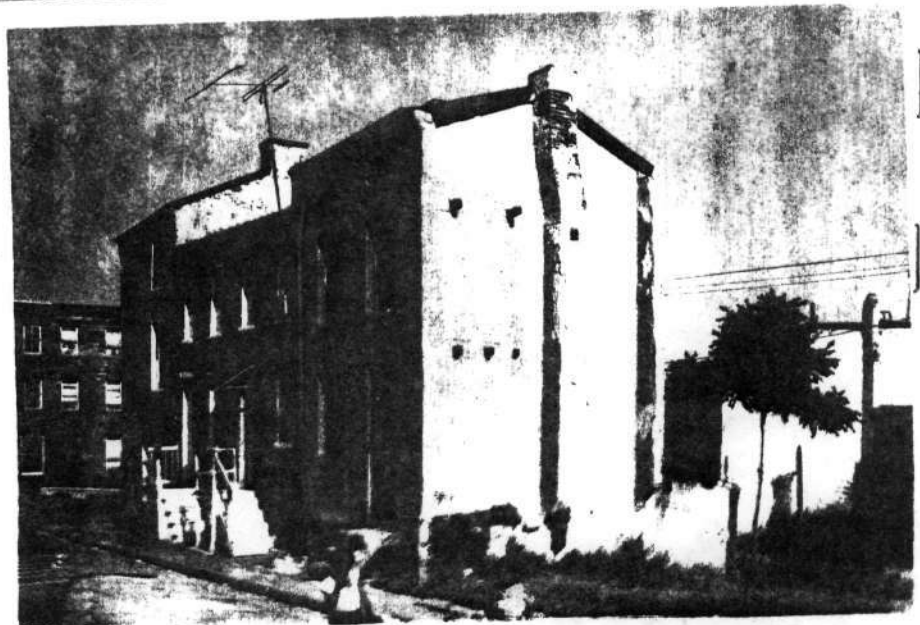
These houses, plus the condition of 114-116 Parkin Street, blight the streets adjacent to them. Number 879 is formstoned and derelict.

Lots (61-66) at 881-891 Lemmon Street have been cleared and 879 is vacant. Across-street two old houses stand alone among cleared lots. Would be better to clear this interior block; however, a word of caution, to wit, what holds up what: a structural analysis is needed to be sure that removing 875-877 Lemmon Street wouldn't be fatal to 114-116 Parkin.
